HOME INSPECTION REPORT

File Number: **SAMPLE REPORT**

Address of Inspection: **1234 Fifth Ave**

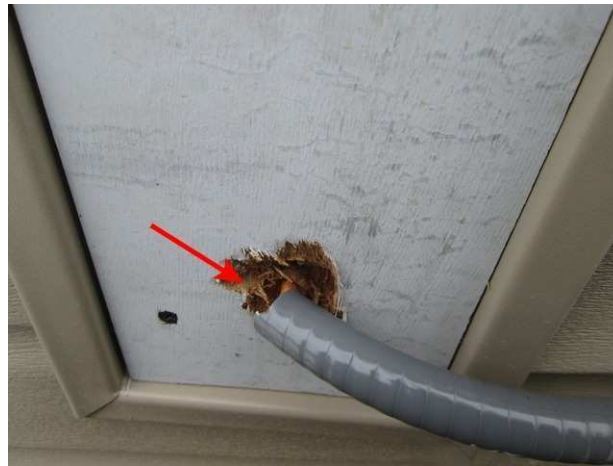
The area of the siding where the A/C power supply enters the home should be sealed to prevent water intrusion.

A/C electric supply

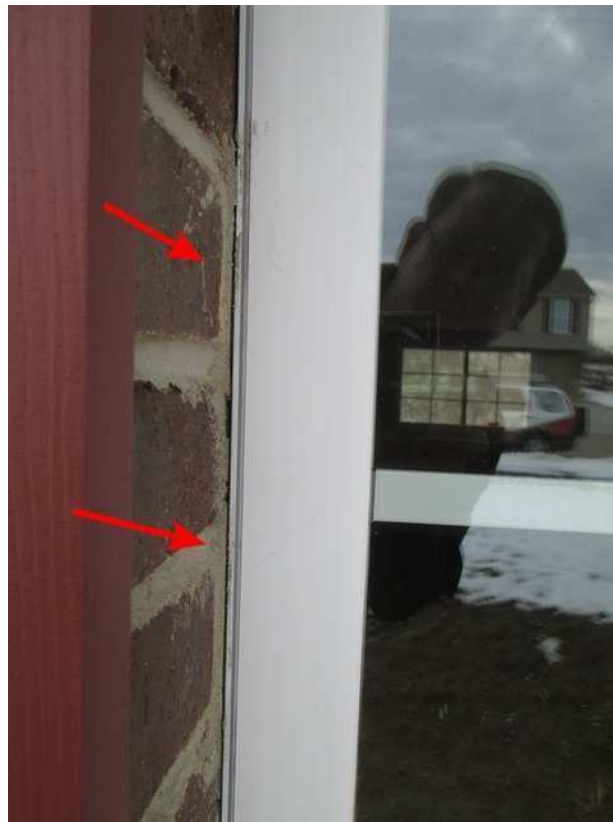
The windows on the front of the home need to be caulked. This will prevent water intrusion and help with energy efficiency.

Missing caulk on front lower window

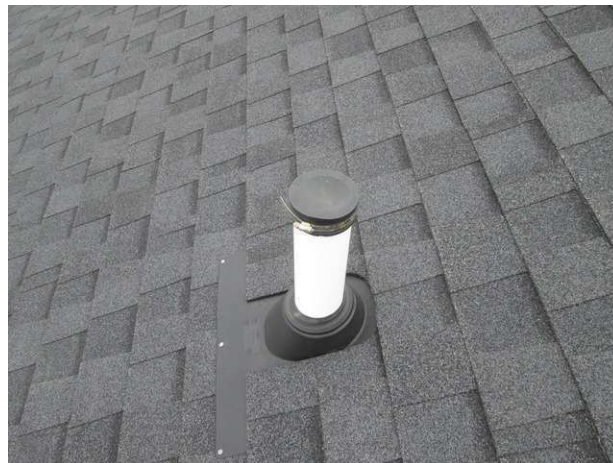
The test cap for the plumbing stack was in place and still needs to be removed.

Remove plumbing stack cap

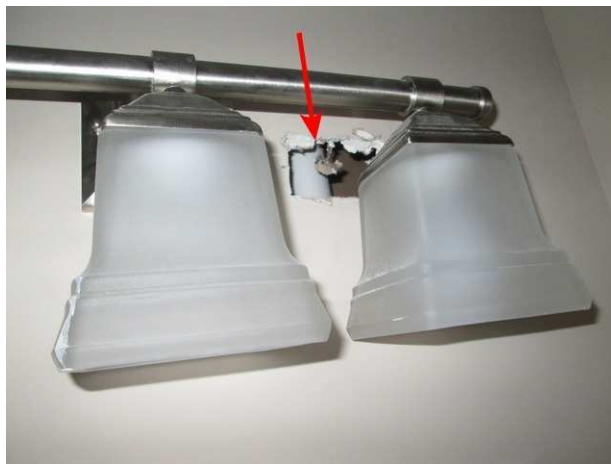
There was a hole in the drywall above the half bathroom sink.

Drywall damage in half bath above sink

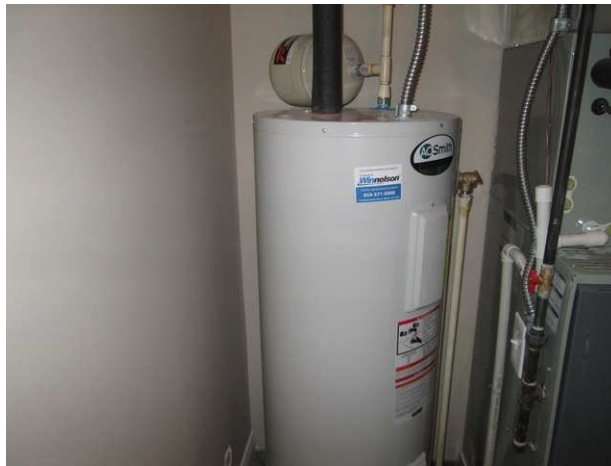
Water heater

A temperature and pressure relief valve (T & P) was present. Because of the lime build-up typical of T & P valves, we do not test them. An overflow leg was present. It did terminate close to the floor. Your safety depends on the presence of a T & P valve and an overflow leg terminating close to the floor. The water heater was functional.

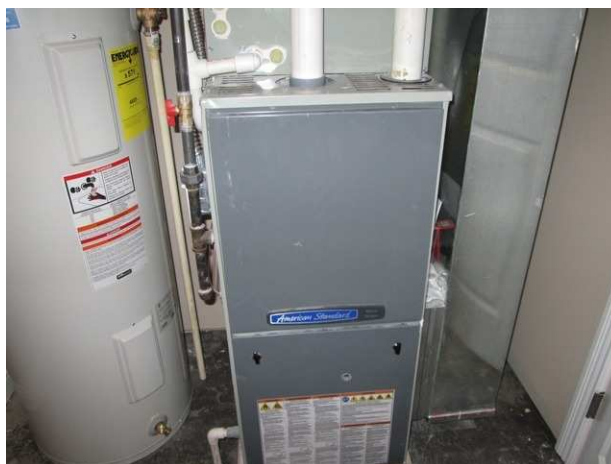
Furnace

Termination of HVAC condensate lines was raised above the floor drain or drain inlet. The condensate lines were trapped. HVAC condensate lines must be trapped and not in contact with wet drain inlets to prevent the possible migration of bacteria and mold into the air-handling system. The heating system was found to be functional.

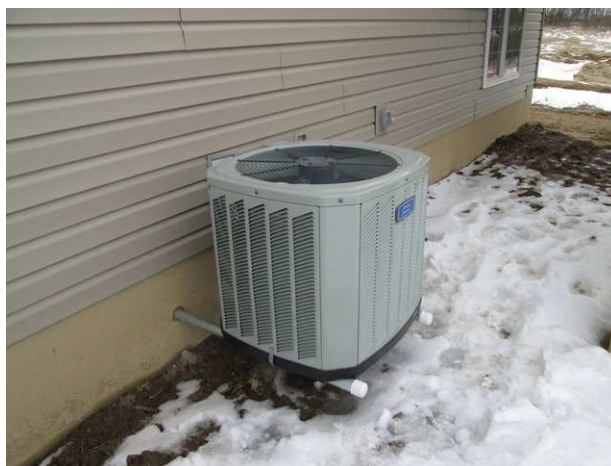
A/C unit

The cooling system was visually inspected but was not operated due to cool or cold exterior temperatures. When outdoor temperatures have been below 60 degrees Fahrenheit within the past 24 hours, extended operation of the cooling system could damage the compressor. The compressor was operational but the Freon levels could not checked and will need to be further evaluated when the outside temperature is above 60 degrees. It is recommended that the system be cleaned and serviced when outside temperatures can safely allow the unit to be operated without risk of damage to the unit.
