HOME INSPECTION REPORT

File Number: **SAMPLE REPORT**

Address of Inspection: **1234 Fifth Ave**

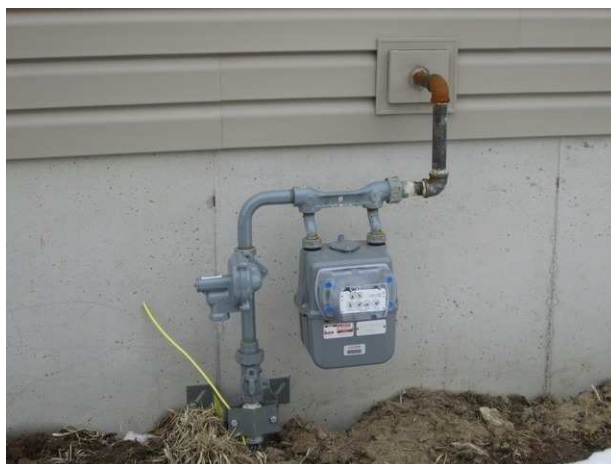
The gas meter was located on the right exterior wall. Although no actual testing was performed to detect the presence of gas fumes, there was no noticeable odor of gas detected at the time of the inspection.
